# Manhole Inspection Summary

Manhole # S59K\_\_016MH

**Inspection** ☐ Is Incomplete Rating: **5) Immediate Attention Required**

**Location** Address: **rear 4500 fait ave**

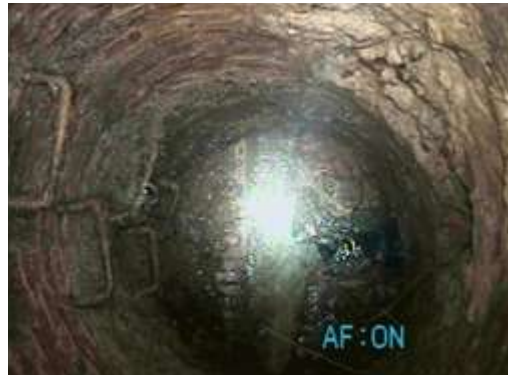
Top View

Comments **Roots are all over the manhole**

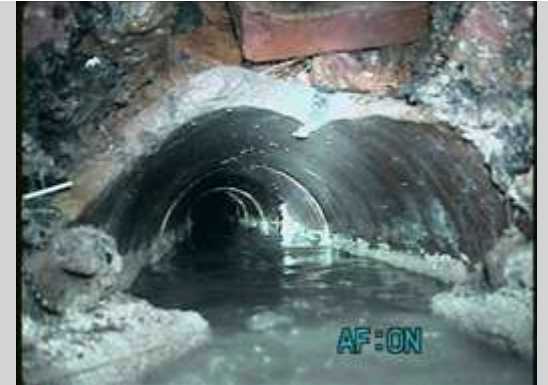
12 O'Clock Outflow

18 in. Circular Gravity Sewer  
Pipe Out @ 12 O'Clock

Pipe Material: **Clay** ☐ Pipe Lined

Invert Depth: 11.75 (ft.) Flow Characteristics: **Fast**

Deposits: ☒ None ☐ Mud ☐ Sludge ☐ Debris ☐ Grease

Infiltration: **None** Pipe Seal Cond: **Unknown**

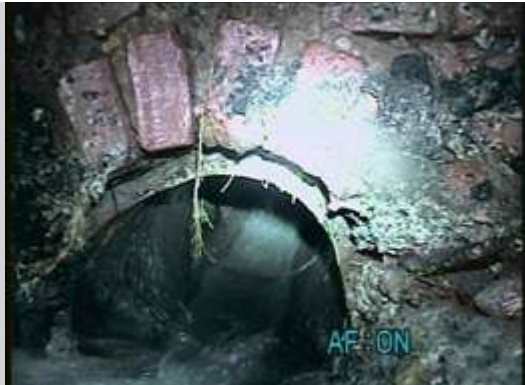
6 O'Clock Inflow

8 in. Circular Gravity Sewer

Pipe In @ 6 O'Clock

Pipe Material: **Clay** ☐ Pipe Lined

Infiltration: **None** Pipe Seal Cond: **Unknown**
